HEAVENLY VALLEY RESORT CANYON TEST PLOTS REPORT

May 2008

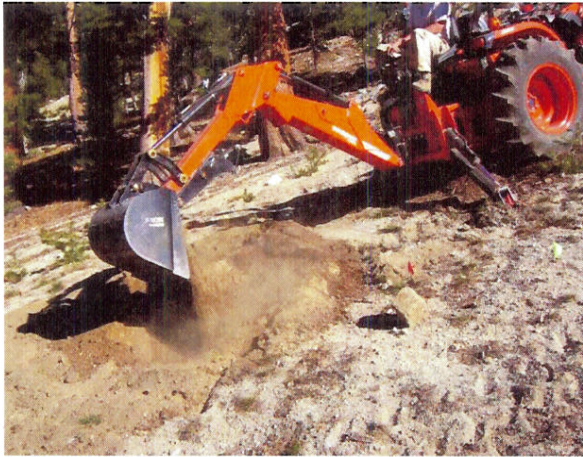
Figure 5. Tilling with a Kubota tractor and Wood's backhoe.

After amendments were applied, they were tilled into the soil to a depth of at least 12 inches (30 cm). Tilling of the soil was completed with a Woods backhoe attached to a Kubota 3830 tractor (Figure 5). Each plot was tilled with the tractor positioned on the uphill side of the slope to minimize downslope movement of material. Due to logistical problems and the steepness of the slope, plots 1, 2, and 11 were tilled with a Gradall 43 foot reach forklift.

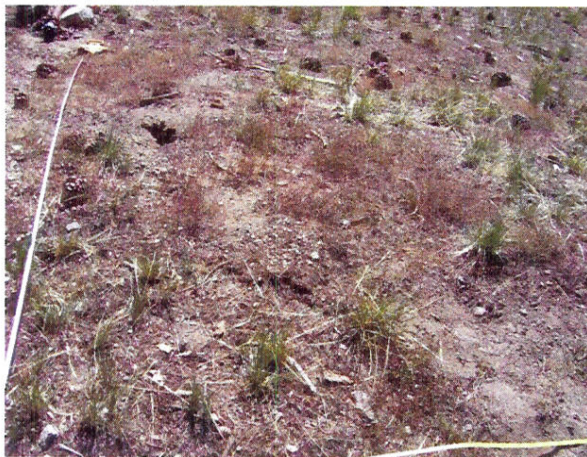
Figure 7. Plot 27, 6 Coarse overs and Biosol in 2006. Ocular estimate of total cover is 52%.

These two sets of photos illustrate the difference between plant cover values obtained from ocular estimates and cover point measurements (Figure 7, Figure 8, Figure 9, and Figure 10).

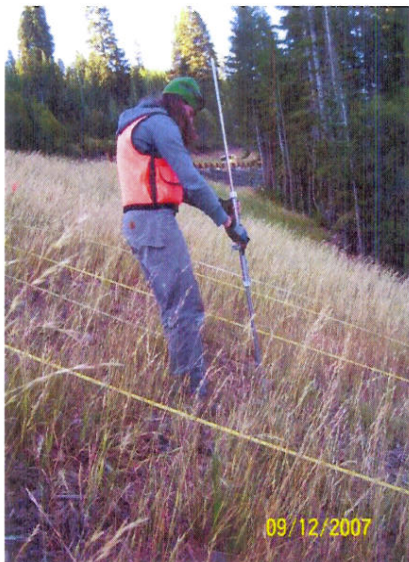
Figure 11. Cover pointer in use along transects.

In 2007, cover was measured using the cover point method along randomly located transects.¹ Cover point monitoring is a statistically defensible method of measuring plant and foliar cover (hereafter referred to as either “plant cover” or “foliar plant cover”), plant composition and mulch cover. The cover pointer consists of a metal rod with a laser pointer mounted 3.3 feet (1 meter) high. After the rod was leveled in all directions, the button on the laser pointer was depressed and two cover measurements were recorded (Figure 11 and Figure 12):

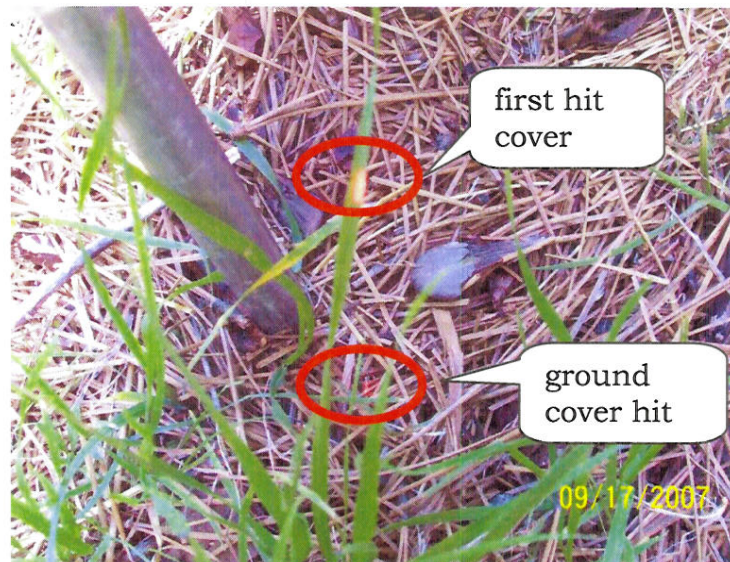
Figure 12. Cover pointer rod with first hit and ground cover hits by the laser pointer. The laser pointer hits are circled in red. The first cover hit is a native grass and the ground cover hit is pine needle mulch.

- the first hit cover, which represents the first object intercepted starting from a height of 3.3 feet (1 meter) above the ground and
- the ground cover hit.

The first hit cover measures the foliar cover by plants (leaves and stems). It does not measure the part of the plant actually rooted in the ground. The ground cover hit measures whatever is lying on the ground or rooted in the ground (i.e. litter/mulch, bare ground, basal (or rooted) plant cover, rock and woody debris). Total ground cover represents any cover other than bare ground.

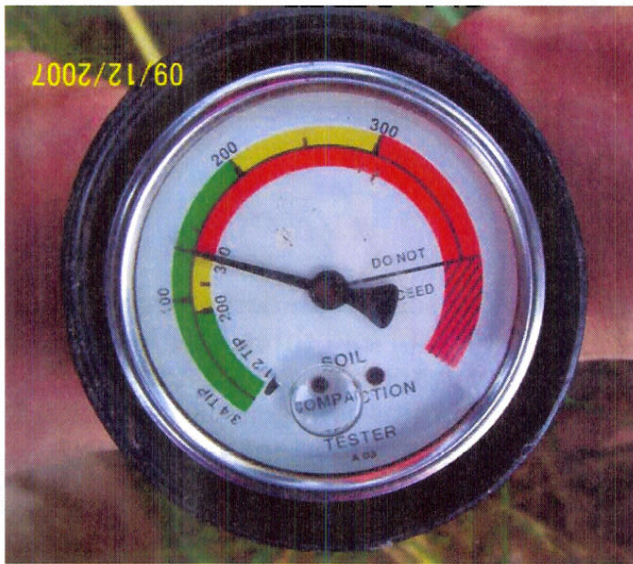
Figure 13. Cone penetrometer dial, showing pressure applied in pounds per square inch.

Cone penetrometer measurements were used as an index for soil density. The cone penetrometer, with a ½ inch diameter tip, was pushed straight down into the soil until a maximum pressure of 350 pounds per square inch (psi) (2411 kPa), was reached (Figure 13 and Figure 14). The depth, in inches, at that pressure was recorded as the depth to refusal (DTR). These depth measurements were used as an index for soil density and infiltration capacity. A denser soil is less likely to allow infiltration. Rainfall simulations conducted on roadcuts in Oregon found increased infiltration rates in soils with penetrometer depths to refusal (DTRs) greater than 4 inches (10 cm).²

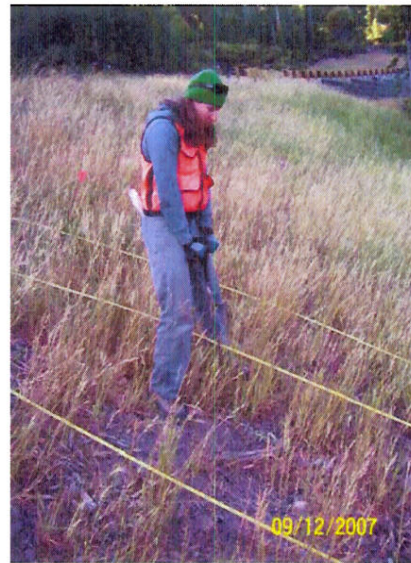
Figure 14. Conducting cone penetrometer readings along transects.

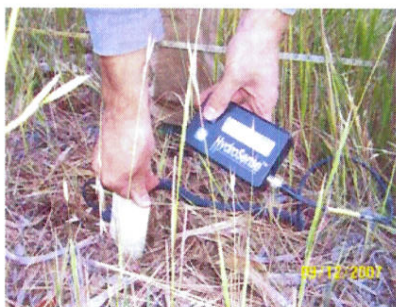
Figure 15. Conducting soil moisture readings along transects.

A hydrometer was used to measure volumetric soil moisture content adjacent to the penetrometer readings at a depth of 4.7 inches (12 cm) (Figure 15). In 2005, an average of 25 random penetrometer readings and 10 soil moisture readings

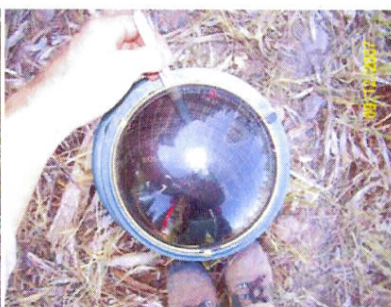
Figure 16. Solar pathfinder in use.

The Solar Pathfinder was used to measure the solar radiation at three locations at the Heavenly test plots (Figure 3 and Figure 16) and three locations at the adjacent native site. Since solar input affects evaporation rates and soil temperature, which may affect time of seed germination, germination rate, rate of plant growth and soil microbial activity, it is an important variable to consider when monitoring plant growth and soil development.

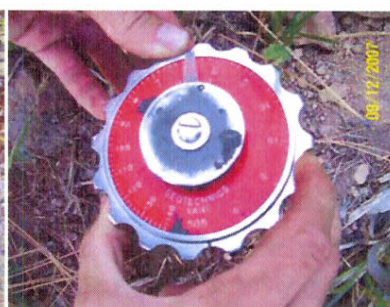
Figure 17. Soil shear strength tester.

Soil strength measurements were collected on the same transects as cover, penetrometer, and soil moisture. To measure soil strength, a hand-held shear vane with 1.5 inch (3.8 cm) long blades was pushed into the soil to a depth of 3 inches (7.6 cm) and turned until the soil could no longer resist the force exerted by the blades and the soil structure fractured or deformed (Figure 17). This force was then recorded as the “shear stress” in kilopascals (kPa). Forty kPa was the maximum force the shear vane could measure. Any values above 40

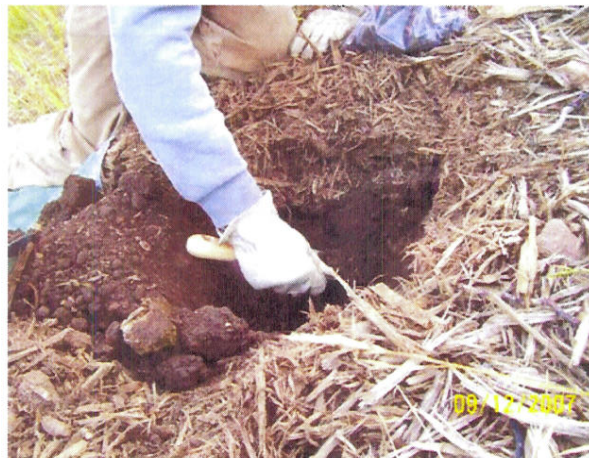
Figure 18. Soil sub-sample collection

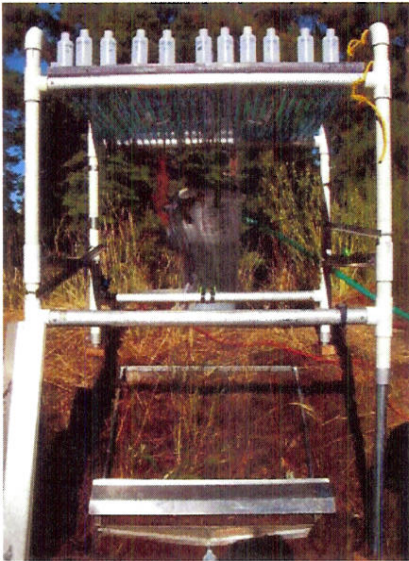
Figure 19. Photo of the rainfall simulator and frame.

The rainfall simulator "rains" on a square plot from a height of 3.3 feet (1 meter) (Figure 19 and Figure 20). The rate of rainfall is controlled, and runoff is collected from a trough at the bottom of a 0.6 square meter (6.5 square feet) frame that is pounded into the ground. The volume of water collected is measured; then the volume of infiltration is calculated by subtracting the volume of runoff from the total volume of water applied to the plot. If runoff was not observed during the first 30 minutes, the simulation was stopped. The average steady state infiltration rate was calculated and will hereafter be referred to as "infiltration rate". The collected runoff samples were then analyzed for the average steady state sediment yield (hereafter referred to as "sediment yield").

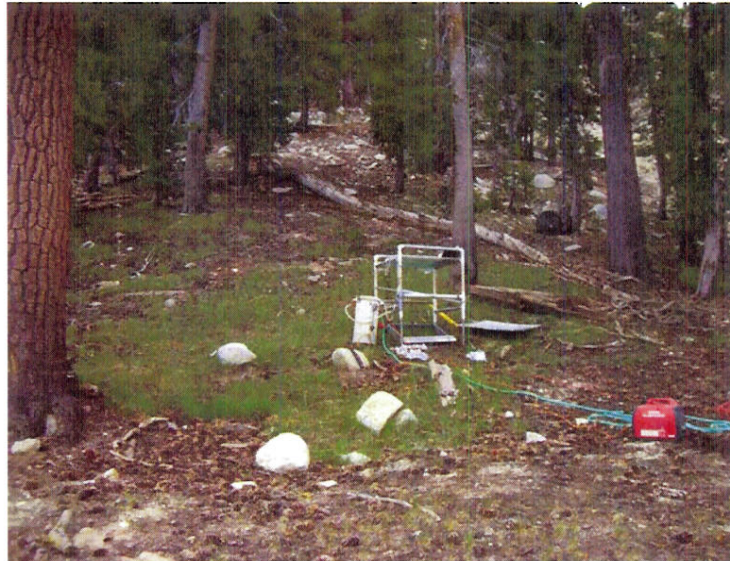
Figure 20. Photo of the rainfall simulator at the native site, 2006.
